# Vibration Analysis

16 August 2006

A Vibration report on  
Various Items

A Plant  
Somewhere

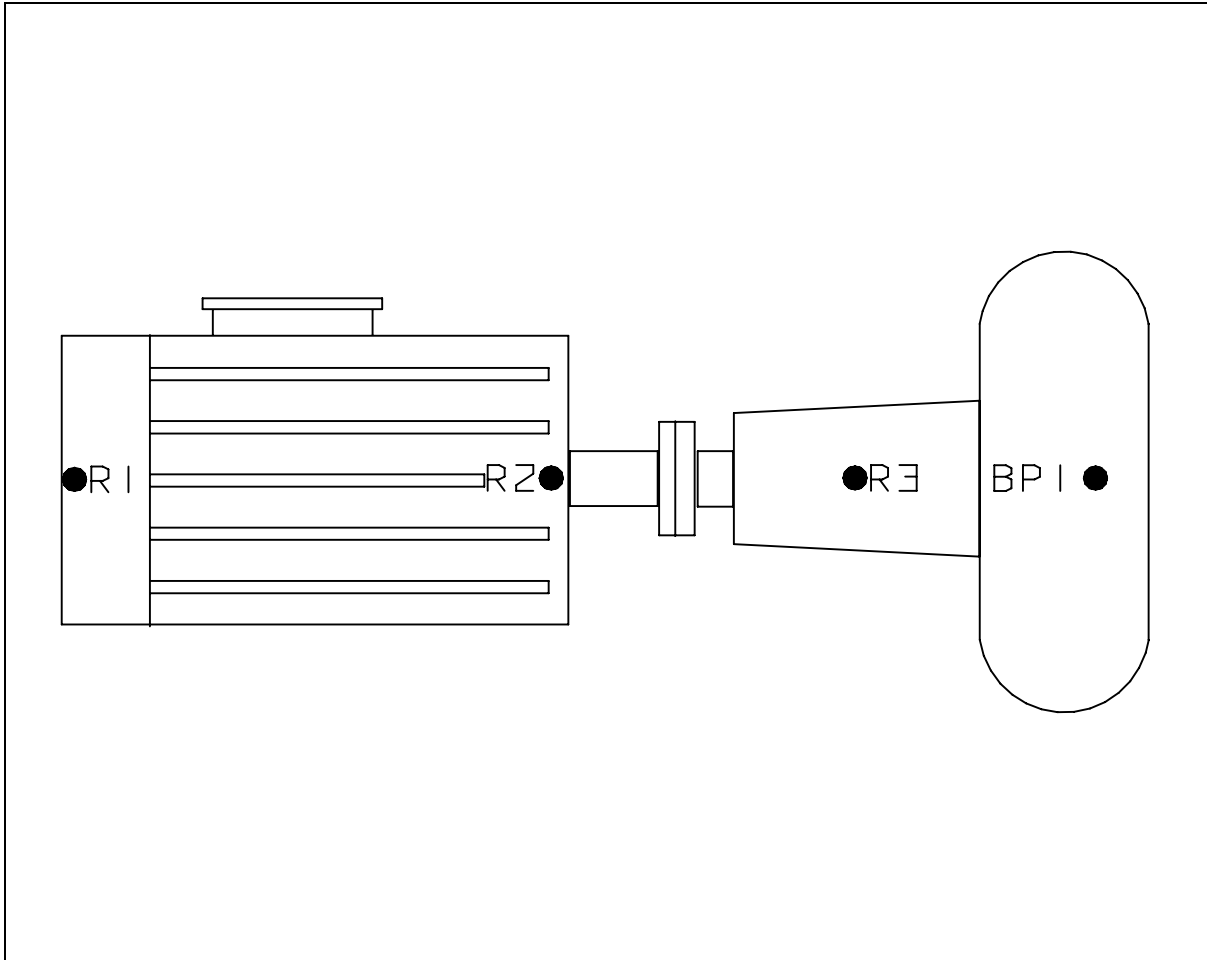
### 41/212 Brine Pump

As can be seen, there has been a steady increase over the last few readings. However, the levels are only at about 40% alarm limits and are still well short of what they were prior to the failure of the previous pump.

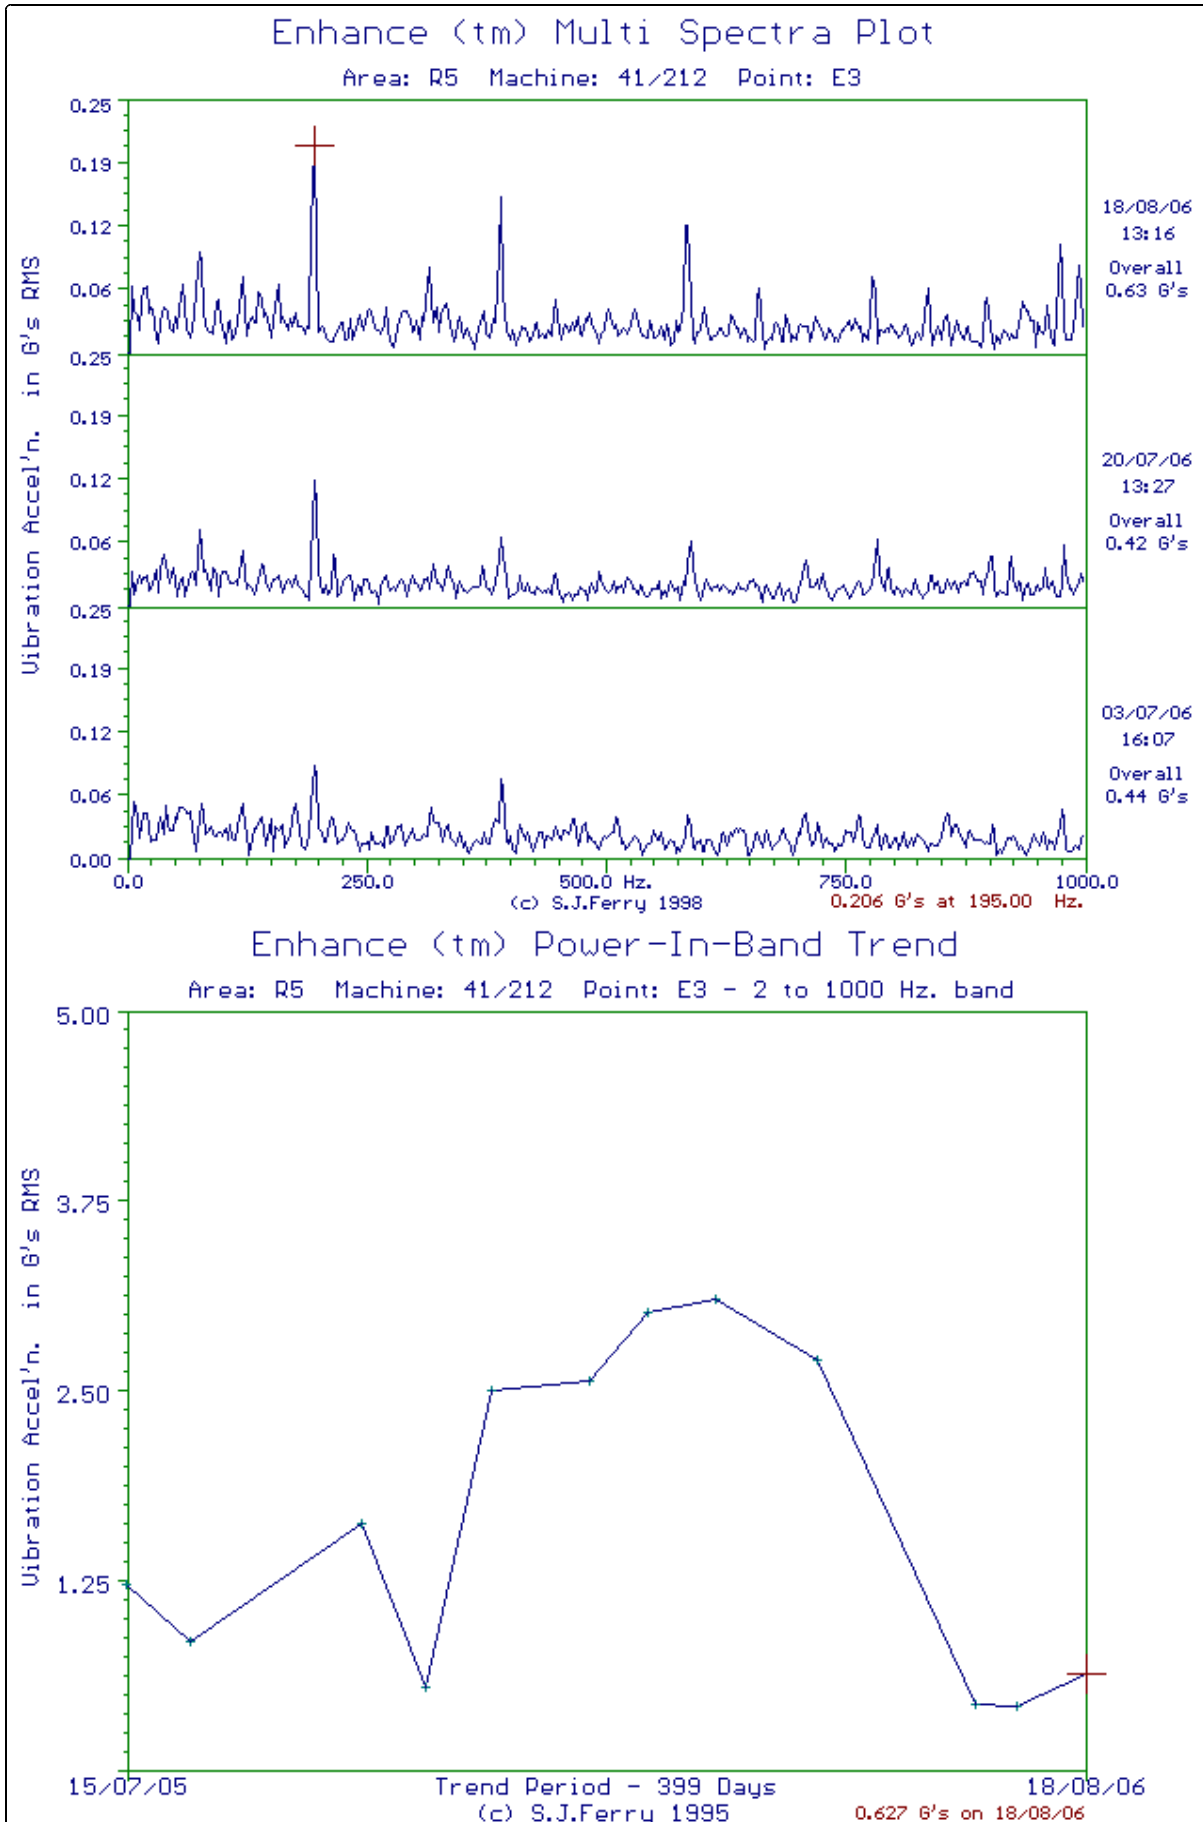
Plot 1 shows the ESP spectras and trend from the pump bearings.

As has been previously discussed, the concrete plinth is not in a very good condition and this is a contributory factor to the reduction in pump condition. It is understood that this is to be addressed during the annual shutdown and a new plinth cast. It may also be prudent to replace the pump to ensure longevity as the current one is certainly indicating some early warning signs of damage. In the meantime, caution is recommended.

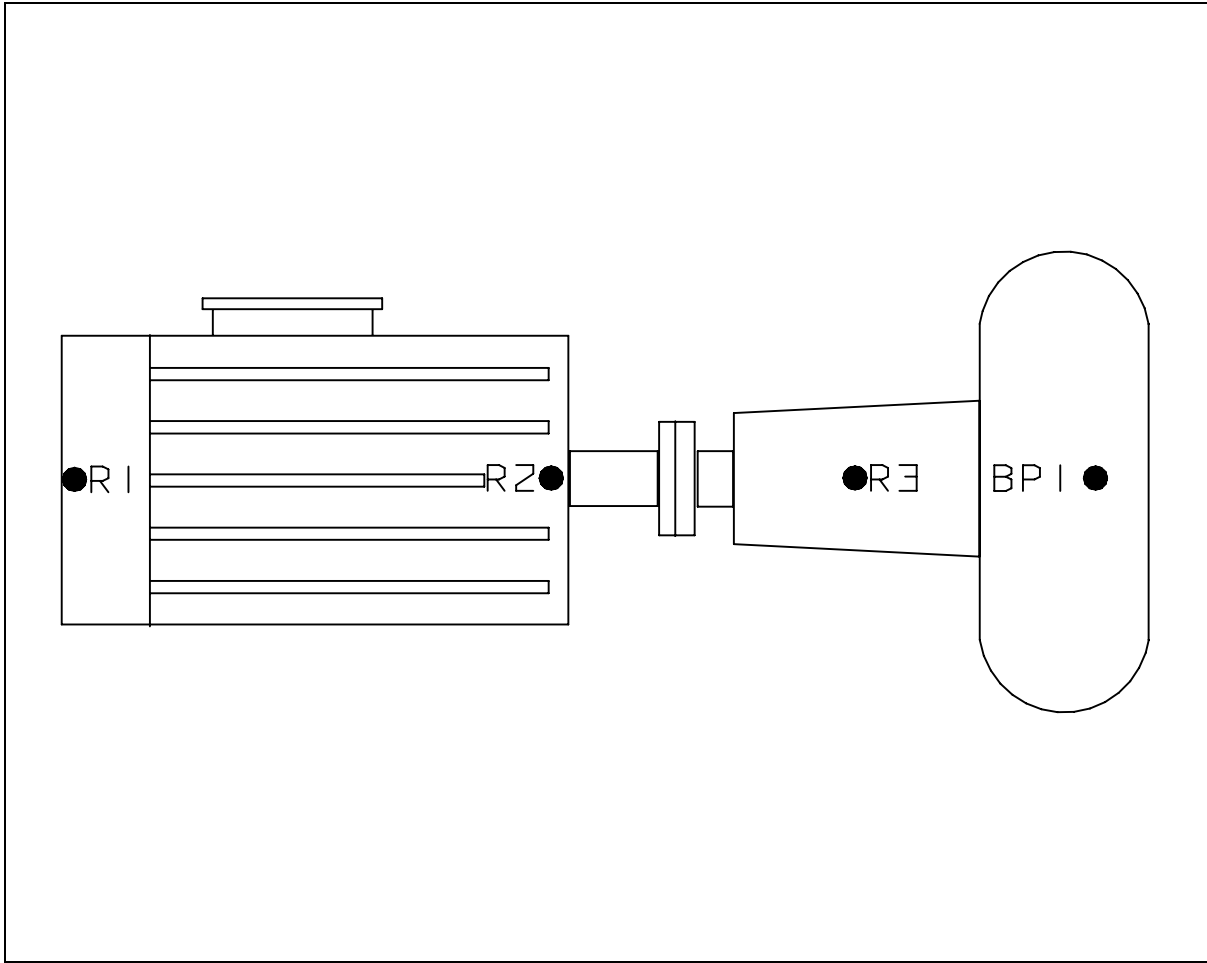
### 52/115 Transfer Pump

It was reported previously that the pump had become noisy and that there had been a further increase in activity taking it well above alarm limits. As can be seen, the activity is still above alarm limits of 0.5G's

It is again recommended that the pump should be changed as a mater of urgency.

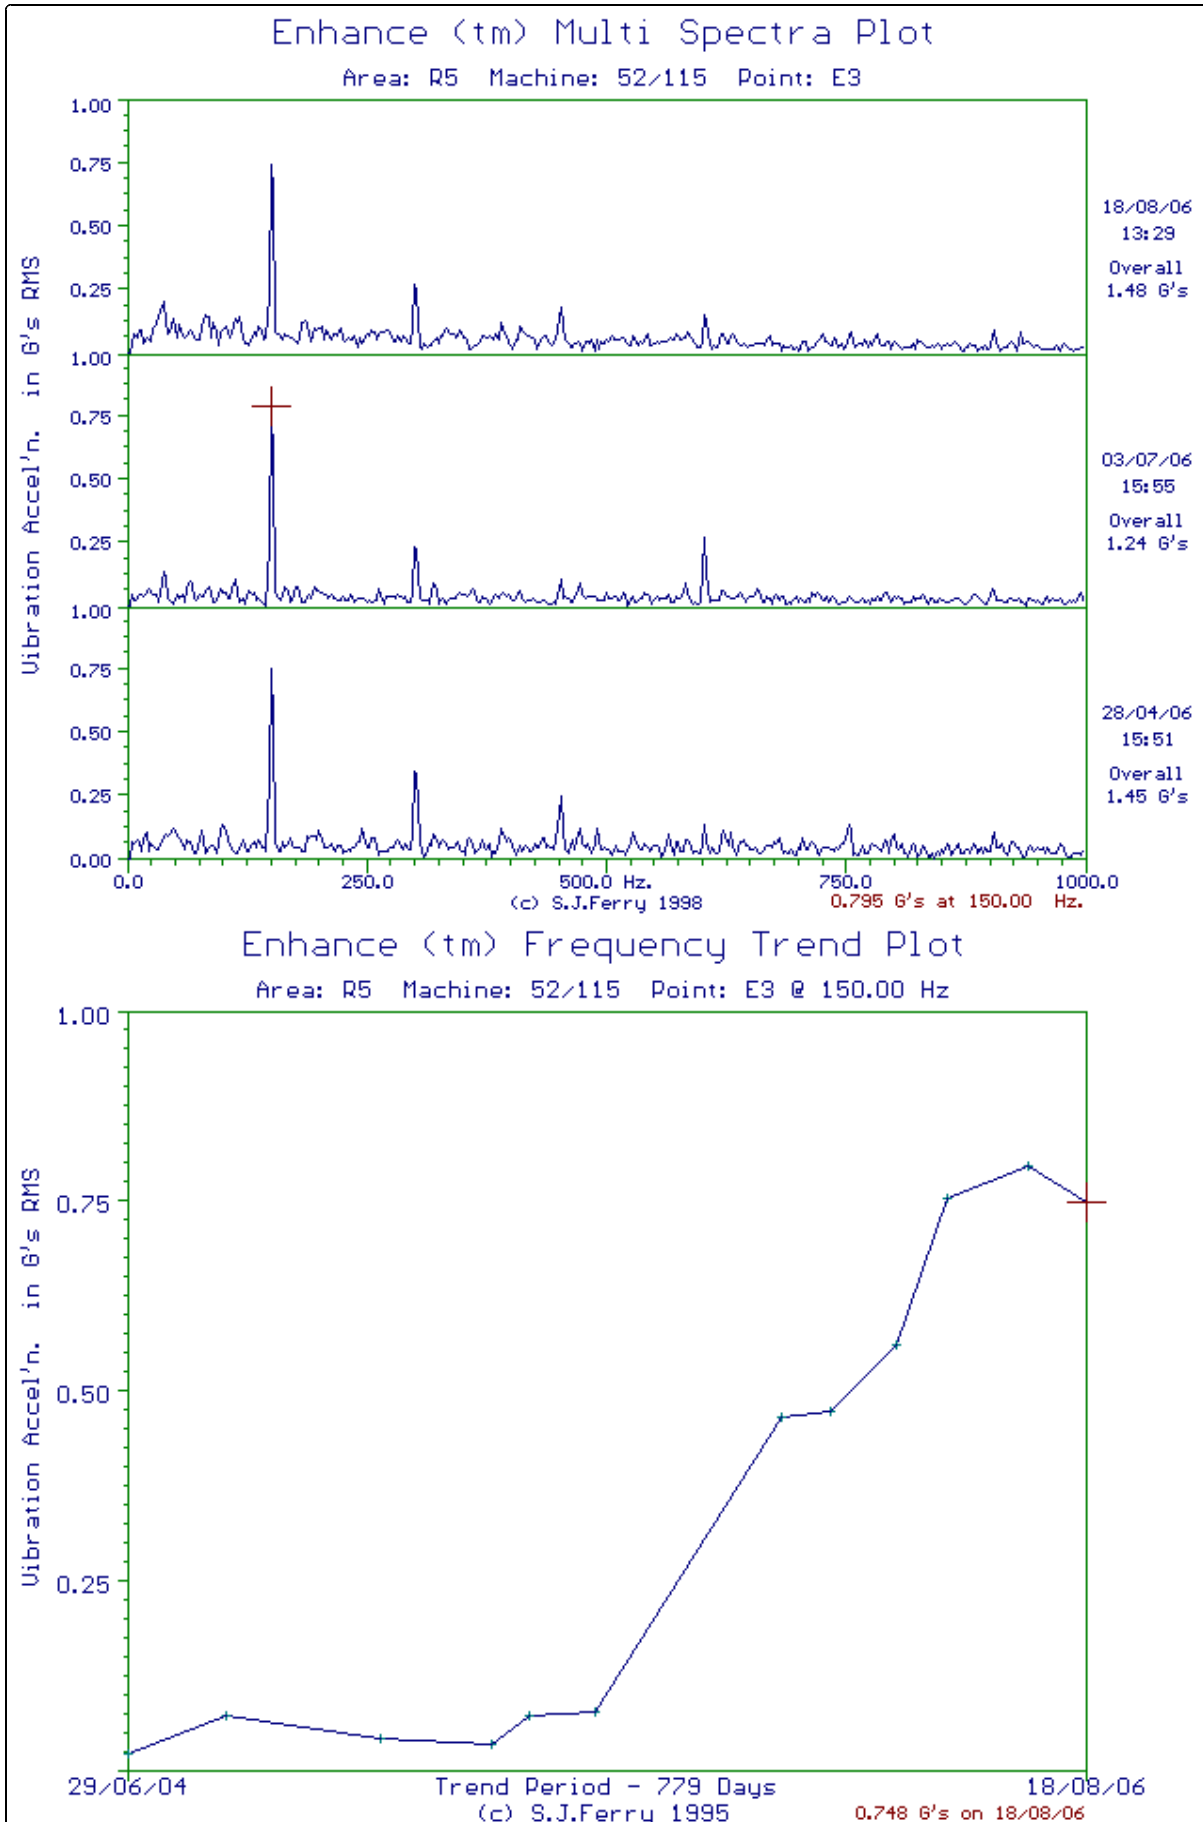
Plot 2 shows the ESP spectras and trend from the pump bearings.
